## Panther Service Bulletin – Mandatory

**Aircraft:** Panther LS and Panther Sport

**Bulletin Name:** PSB2-M Tail Wheel Bolt

#### Regarding: Mandatory Tail Wheel Bolt

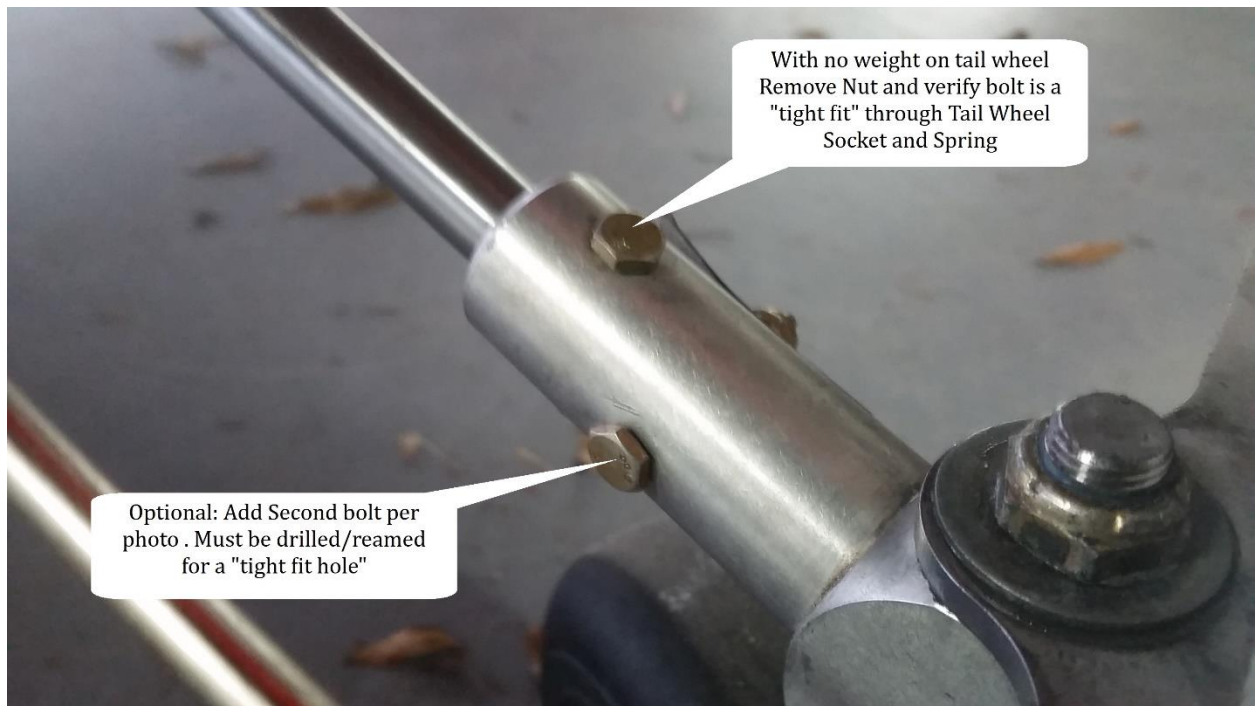
Recently a Panther With a 6"API tail wheel sheared the AN3 bolt that attaches the "tail wheel" to the "tail wheel spring". The bolt sheared while taxiing on grass upon return from a flight when turning with the tail wheel castered to one side. It appears like the bolt sheared from torsional (twisting) load being transmitted into the Tail Wheel Spring due to the tail wheel being to one side. No other damage occurred.

2. We recommend installing a second bolt per the photo, crosswise  $\frac{3}{4}$ ” behind the first. It MUST be installed into a “tight fit” hole!
